# Nave Antenas Moyano, Leganés tecnológico (Madrid)

Localización:	Leganés (España)
Cliente:	Antenas Moyano SL
Fecha:	2009

Los trabajos acometidos en este proyecto abordan el análisis de patología, estudio de soluciones y desarrollo del proyecto de reparación de un edificio destinado a uso industrial, que, en el momento del encargo, se halla en proceso de construcción.

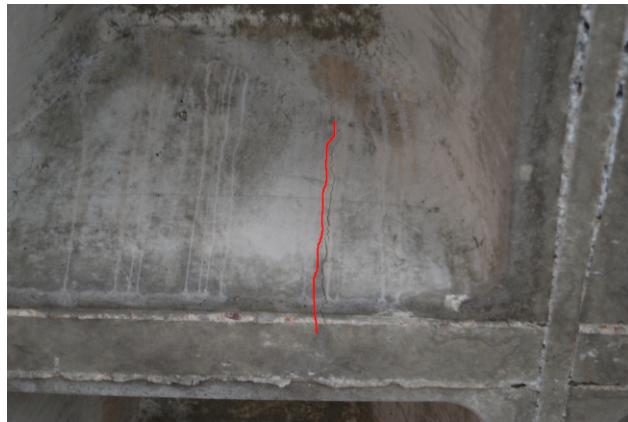
Durante la construcción del mismo se detecta la aparición fisuras en los forjados con apertura entre 1 y 3 mm. Se trata de fisuras quasi-verticales que se presentan de forma sistemática en el encuentro de los nervios del forjado reticular con el ábaco; en general se observa una sola fisura en cada nervio.

(a) Fisuras observadas en el forjado de planta cubierta, en el encuentro de los nervios del reticular con los ábacos de menor longitud en el sentido de la luz principal

Los resultados de detección de armadura realizados con pachómetro apuntan en la dirección de que la referida inexactitud del proyecto se ha reflejado sistemáticamente en la obra ejecutada. Esto también explica la aparente paradoja de que en el lado del forjado donde los ábacos tienen mayor longitud en el sentido de la luz principal, la fisuración está mucho más desarrollada que en el lado opuesto, ya que en estas zonas la armadura de flexión positiva del nervio se habría cortado antes y, por tanto, con mayor momento positivo. Este extremo se confirma verbalmente con el técnico encargado de la obra, quien confirma que la armadura de flexión positiva de los nervios se dispuso en la forma señalada, es decir, 2Φ25 en cada nervio del reticular y 1Φ12 en prolongación del nervio en el ábaco, realizándose el solape mediante prolongación del Φ12 hacia el nervio.

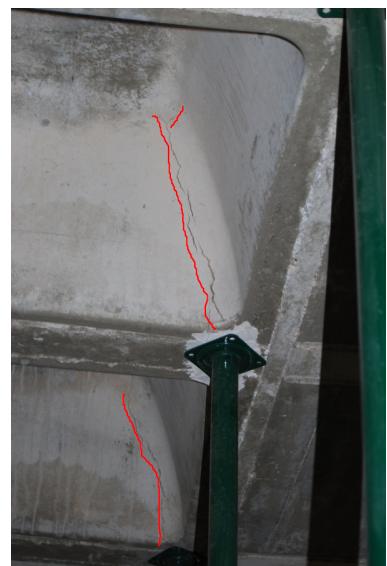
(b) Fisuras observadas en el forjado de planta cubierta, en el encuentro de los nervios del reticular con los ábacos de mayor longitud en el sentido de la luz principal

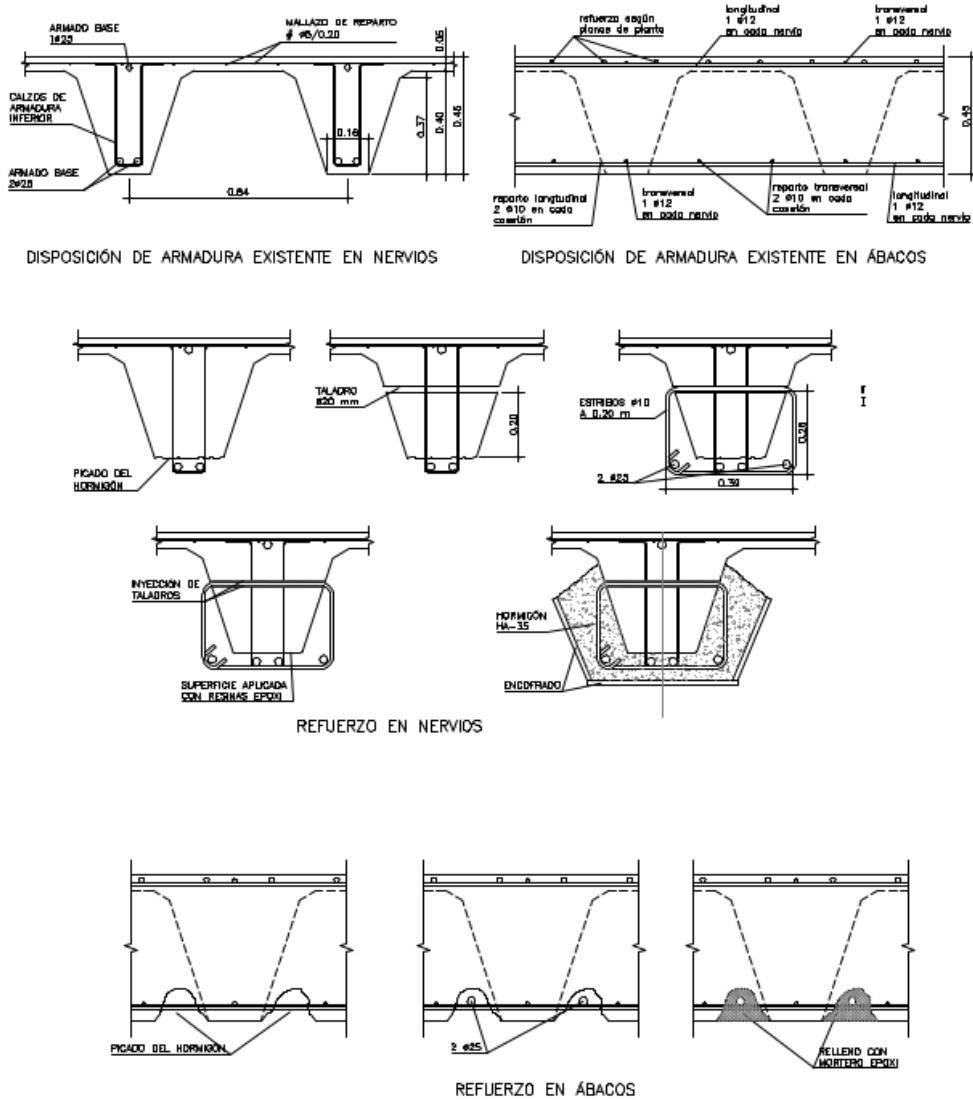
Figure 2. Esquema de la solución proyectada (alternativa C)

C.- Refuerzo mediante disposición de armadura de tracción en las zonas en que ésta resulta insuficiente.

propiedad en base a criterios económicos. Se desarrolló, por tanto, el proyecto constructivo de la solución C, permitiendo en un futuro emprender una nueva intervención basada en el empleo de armadura postesa, si se desea corregir la deformación excesiva de los forjados.
